What's Wrong With the MU-2?

Is the fault with the airplane or the pilots and mechanics?
We flew it to find out some of the answers.

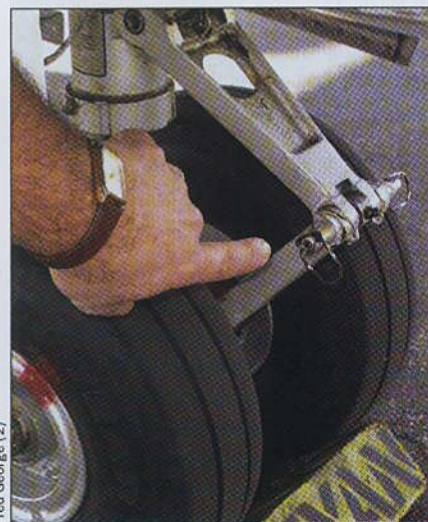
Nosewheel steering linkage must be disconnected for towing. Don't forget to replace the quick release pin in the scissors link before start.

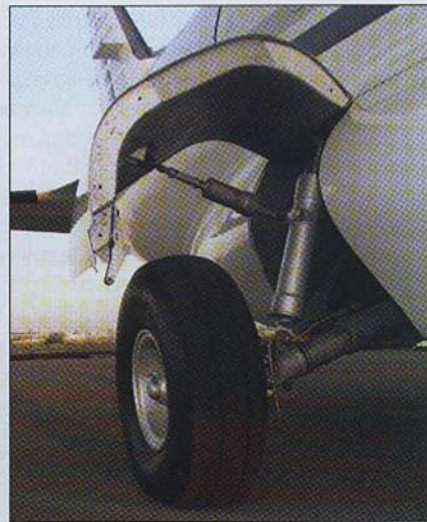
The main landing gear are beefy, well-suited for rough field operations. On long-body models, they're positioned 16-inches aft of the c.g.

Rotation forces at 102 KIAS were considerably heavier than in some turboprops because the main landing gear are well aft of the center of gravity. Minimum rotation speed in the Marquise is never less than 100 KIAS because V_{MCA} is 99 KIAS. Initial pitch force is much heavier in short body models because the horizontal tail is closer to the c.g. and the main gear are much farther aft of the c.g. With weight off the wheels, pitch force was much lighter and we had to take care not to over rotate beyond the recommended eight-degree nose-up attitude. The aircraft quickly accelerated through 120 KIAS.

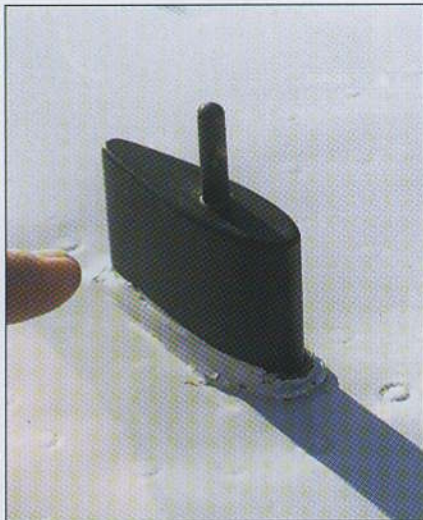
An optional ice detector is a must, in our opinion. It provides the crew timely warning about impending ice accretion so that ice protection systems can be used effectively and an exit strategy can be executed.

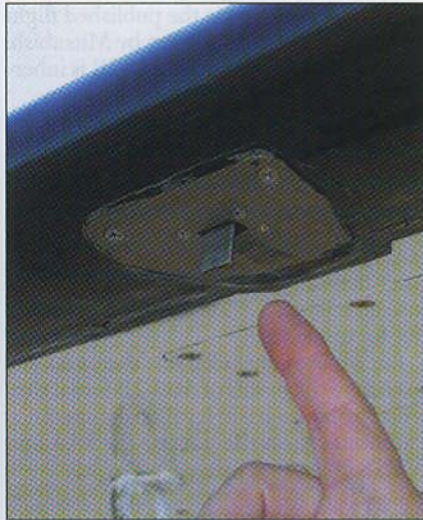
The stall detector on the right-wing leading edge is linked to the stall-warning stick shaker.

"It flies like a Patriot missile with the flaps up and a Cessna 172 with the flaps down." At MTOW, for instance, the Marquise stalls at 105 KIAS in the clean configuration, but only 87 KIAS with flaps set to 20 degrees. Its 64000-series NACA airfoil also doesn't provide much aerodynamic stall warning, thus the need for a stall warning

stick shaker, a safety device commonly fitted to many jet aircraft.

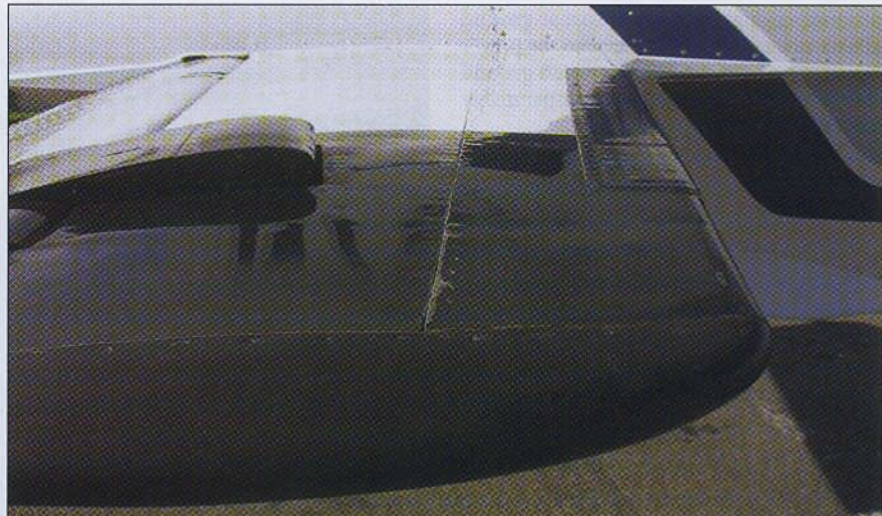
The horizontal tail actually is an upside-down wing. It's very effective and it has been proven to be highly resistant to ice contaminated tail-plane stall during the FAA's icing-related fact-finding focused special certification review in the mid-1990s.

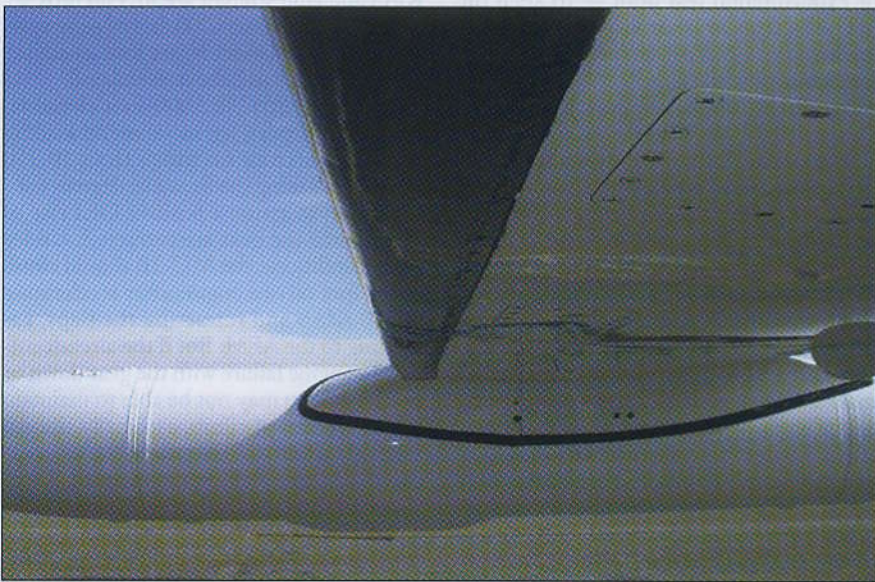
The wings are relatively short and thin. Twin tip tanks that feed the main 154 gallon (1,032 pound) wing tank increase fuel capacity by 180 gallons (1,206 pounds). Aux wing tanks, outboard of the engines, add another 69 gallons (462 pounds) for a total usable capacity of 403 gallons (2,700 pounds).

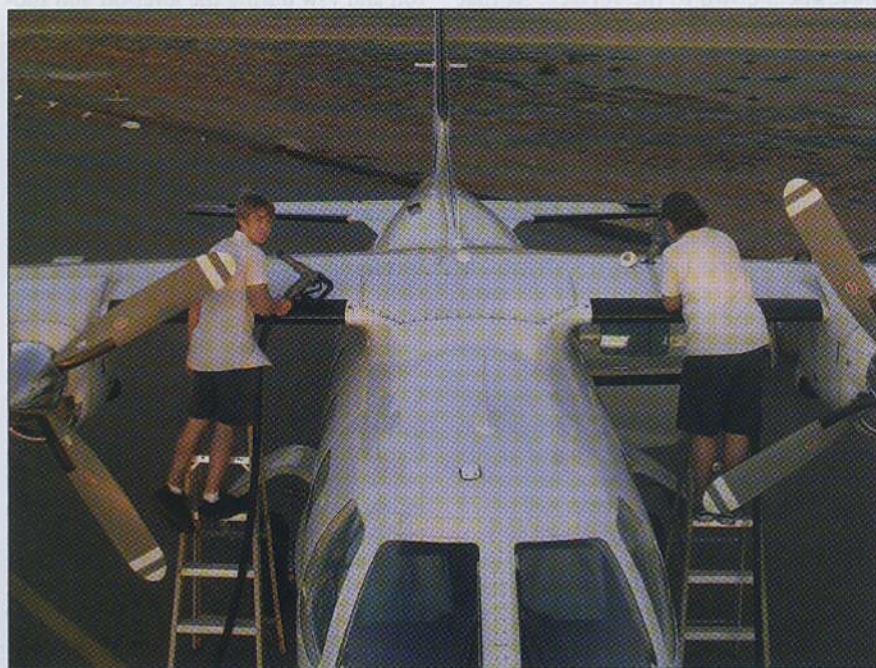
Crownair's Devin Funderburg and Greg Scott refill the main tanks. The aux tanks and tiptanks must be refilled separately, if needed. Pilots need to check all six fuel caps on preflight inspection.
